THE HOLME, CLIVIGER
CONDITION SURVEY APRIL 2005

This report has been prepared on the instructions of Hurstwood to review the condition of "The Holme", Holme Chapel, Cliviger near Burnley.

The Holme, Cliviger, Todmorden Road,
Burnley

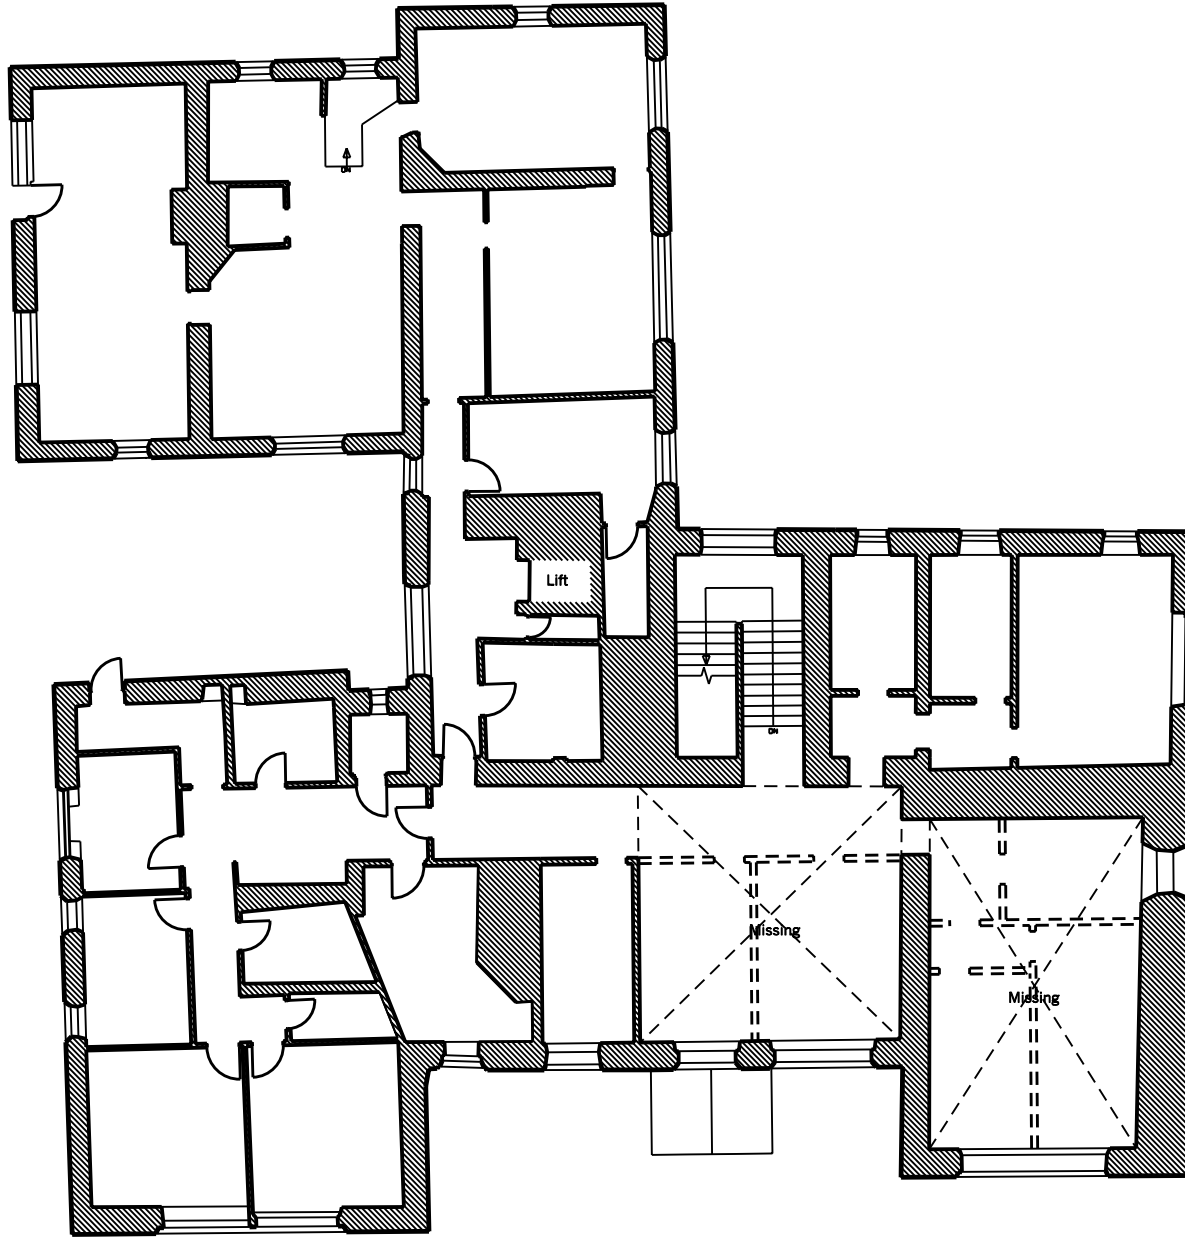
First Floor Plan

- New doors to principal spaces to match existing.
- Replacement window linings to principal areas to original details.
- New fireplaces where appropriate.
- Replicate panelling to limited areas
- Reinststate principal stair to original details
